## Specialty Products **FAQ**

Part Numbers 93080/93090

### Mustang II Dropped Spindles

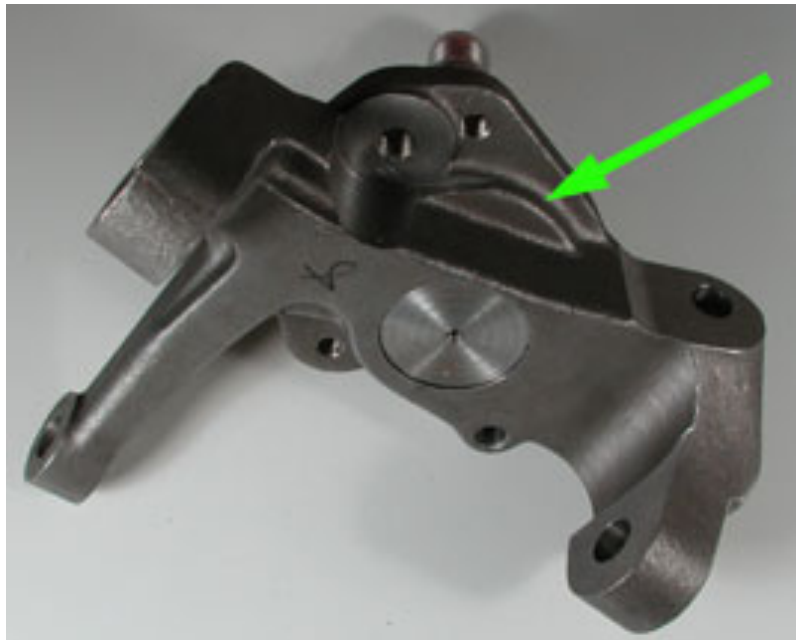
**Q1: The caliper bracket will not fit properly on the new spindle. What can be done?**

**A1:** Some caliper brackets may not fit properly because of a casting protrusion on the back of the spindle housing. This can easily be remedied by grinding of enough of the castings so the brake caliper bracket will fit properly. Fit your caliper bracket and grind off just enough to make mounting bolt holes line up properly. Do not remove any more material than necessary.
